THE BUILDING INSPECTOR OF CONNECTICUT

CONFIDENTIAL INSPECTION REPORT

*26 Maple Drive
Thomaston, CT*

Date of Inspection -	October 17, 2006
Inspector -	Dave Muirhead
Style of Dwelling -	Raised Ranch
Age of Dwelling -	40 ± years
Weather Conditions -	Raining and Cool

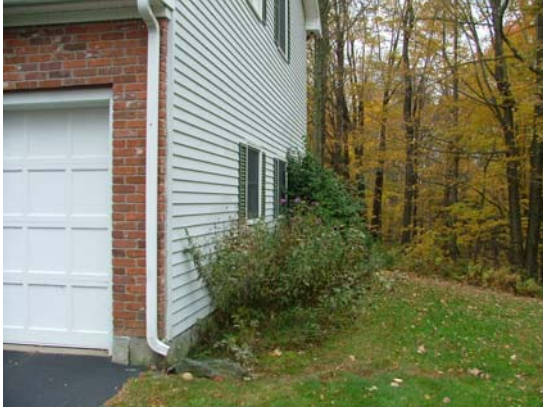
PHOTO # 1

Bushes provide convenient entry for wood boring insects and should be kept trimmed back to avoid contact with exterior siding. See photo #1 on page fourteen.

Bushes should be trimmed away from the structure.

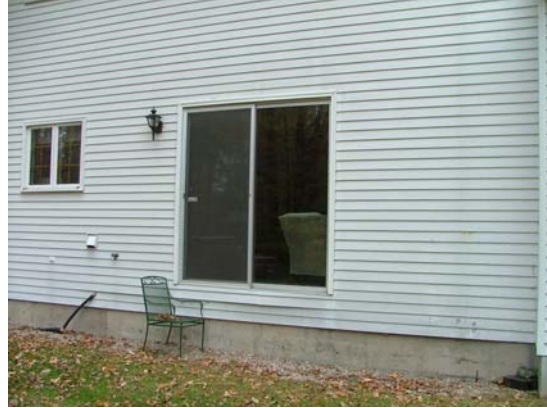
PHOTO # 2

Stair sets should be added to the rear slider and the rear garage door to avoid a potential accident. See photo #2 on page fourteen.

Stairs are needed under the sliding glass door.

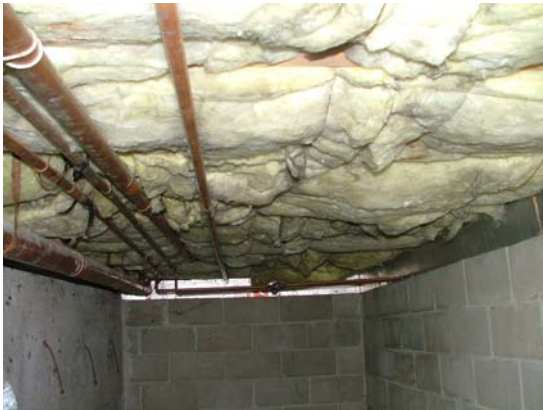
PHOTO # 3

Insulation is covering the crawl space framing.

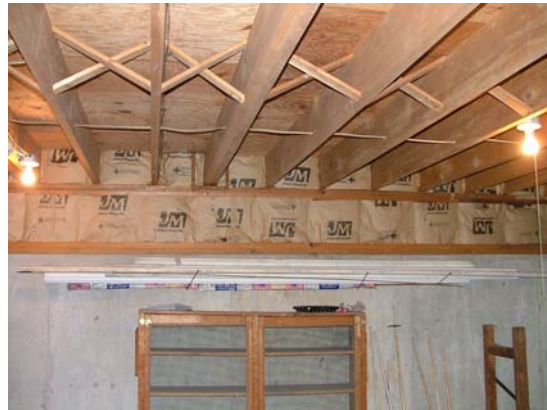
PHOTO # 4

26. INTERIOR FOUNDATION WALLS - MATERIAL - Concrete	SATISFACTORY
27. FOUNDATION FLOOR - MATERIAL - Concrete	SATISFACTORY
28. SLAB ON GRADE -	N/A
29. INTERIOR CHIMNEY - MATERIAL - Block	SATISFACTORY
30. VISIBLE CARRYING BEAMS - MATERIAL - Steel	SATISFACTORY
31. VISIBLE COLUMNS OR POSTS - MATERIAL - Steel	SATISFACTORY
32. VISIBLE FLOOR JOISTS -	SEE COMMENT
	Framing in the crawl space under the half bath is completely covered with insulation. See photo #3 on page fourteen.
33. VISIBLE HEADERS -	SEE COMMENT
	Headers throughout the basement are completely covered with insulation. See photo #4 on page fourteen.
34. VISIBLE SUB FLOOR -	SATISFACTORY
35. VISIBLE SILLS -	SATISFACTORY

Basement headers are mostly covered with insulation.

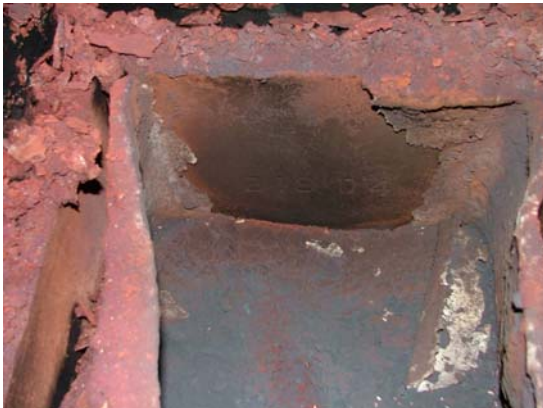
PHOTO # 5

The combustion chamber lining shows signs of deterioration and should be monitored for replacement. See photo #5 on page fourteen.

The boiler chamber lining is deteriorated and should be monitored for replacement

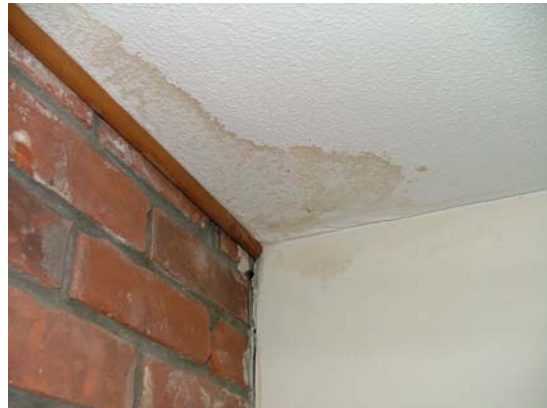
PHOTO # 6

The water stain on the ceiling above the fireplace tested dry when checked with a moisture meter. See photo #6 on page fourteen. The chimney flashing will require periodic resealing to avoid interior water penetration.

Water stain above the fireplace tested dry at the time of the inspection.
