BUILDING INSPECTIONS, INC.

CONFIDENTIAL INSPECTION REPORT

*26 Maple Drive
Thomaston, CT*

Date of Inspection -	October 17, 2006
Inspector -	Dave Muirhead
Style of Dwelling -	Raised Ranch
Age of Dwelling -	40 ± years
Weather Conditions -	Raining and Cool

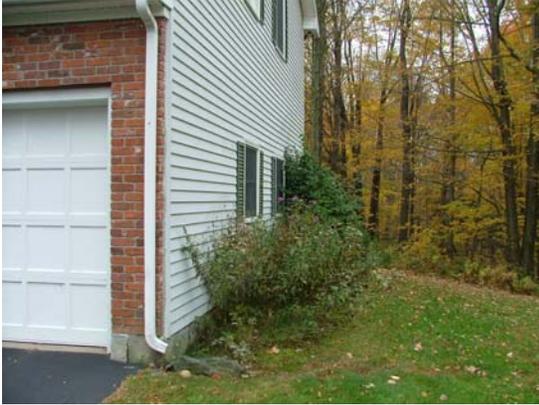
PHOTO # 1

Bushes provide convenient entry for wood boring insects and should be kept trimmed back to avoid contact with exterior siding. See photo #1 on page fourteen.

Bushes should be trimmed away from the structure.

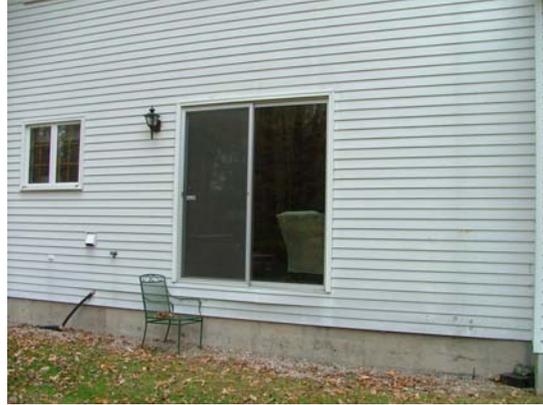
PHOTO # 2

Stair sets should be added to the rear slider and the rear garage door to avoid a potential accident. See photo #2 on page fourteen.

Stairs are needed under the sliding glass door.

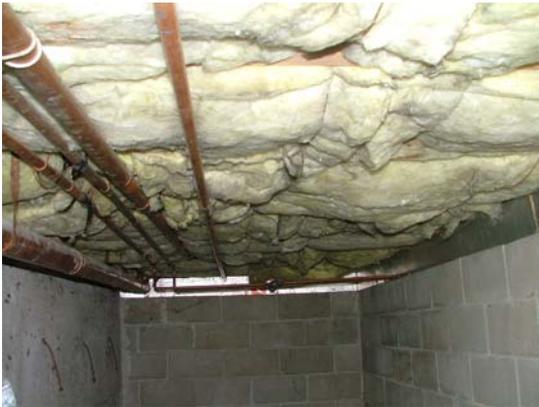
PHOTO # 3

Insulation is covering the crawl space framing.

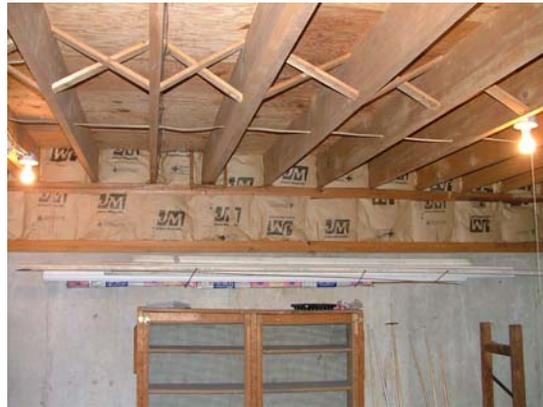
PHOTO # 4

26. INTERIOR FOUNDATION WALLS - MATERIAL - Concrete	SATISFACTORY
27. FOUNDATION FLOOR - MATERIAL - Concrete	SATISFACTORY
28. SLAB ON GRADE -	N/A
29. INTERIOR CHIMNEY - MATERIAL - Block	SATISFACTORY
30. VISIBLE CARRYING BEAMS - MATERIAL - Steel	SATISFACTORY
31. VISIBLE COLUMNS OR POSTS - MATERIAL - Steel	SATISFACTORY
32. VISIBLE FLOOR JOISTS -	SEE COMMENT
	Framing in the crawl space under the half bath is completely covered with insulation. See photo #3 on page fourteen.
33. VISIBLE HEADERS -	SEE COMMENT
	Headers throughout the basement are completely covered with insulation. See photo #4 on page fourteen.
34. VISIBLE SUB FLOOR -	SATISFACTORY
35. VISIBLE SILLS -	SATISFACTORY

Basement headers are mostly covered with insulation.

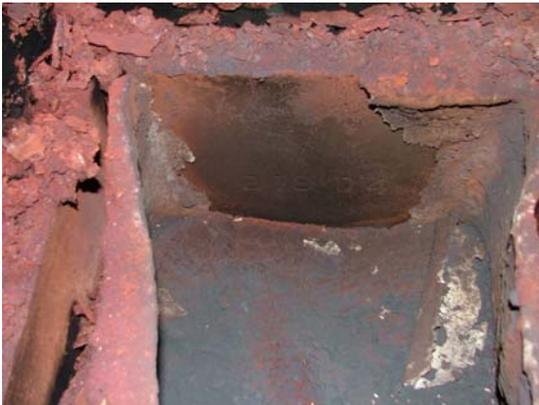
PHOTO # 5

The combustion chamber lining shows signs of deterioration and should be monitored for replacement. See photo #5 on page fourteen.

The boiler chamber lining is deteriorated and should be monitored for replacement

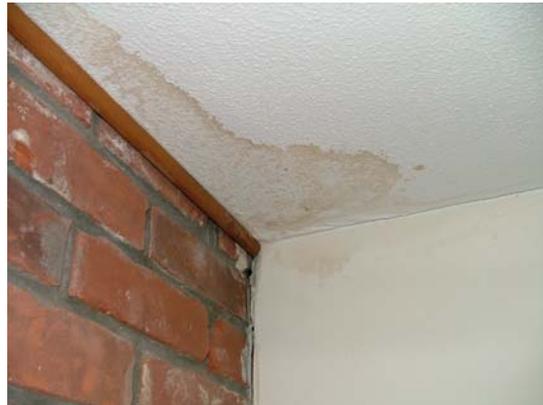
PHOTO # 6

The water stain on the ceiling above the fireplace tested dry when checked with a moisture meter. See photo #6 on page fourteen. The chimney flashing will require periodic resealing to avoid interior water penetration.

Water stain above the fireplace tested dry at the time of the inspection.
