# Wood Destroying Insect Inspection Report

## **CONFIDENTIAL INSPECTION REPORT**

*123 Main Street  
Farmington, CT*

<b>Date of Inspection -</b>	May 1, 2015
<b>Inspector -</b>	Dave Muirhead
<b>Style of Dwelling -</b>	Colonial
<b>Age of Dwelling -</b>	20 ± years
<b>Weather Conditions -</b>	Clear and Warm

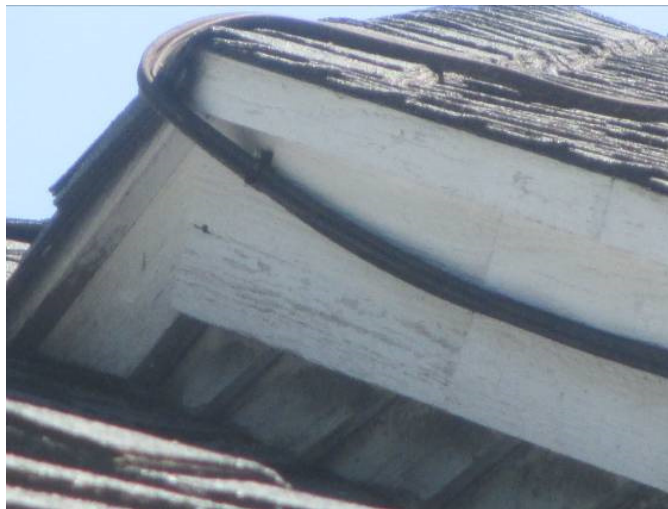
- 4. EXTERIOR TRIM -**  
**MATERIAL - Wood**

Rake board and siding on the west side near the peak appears to be moisture damaged and should be replaced. If not damaged it can be painted.

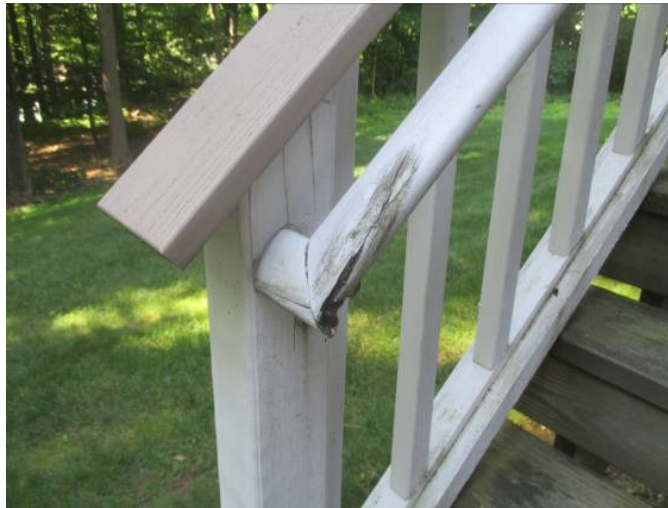
**5. EXTERIOR ATTACHED STAIRWAYS AND LANDINGS -**  
**MATERIAL - Brick**  
**- Wood**

The base of the deck handrail shows signs of rot.

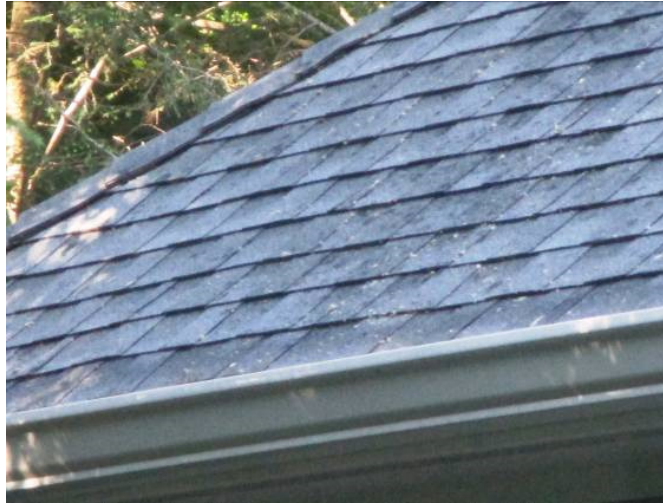
**12. ROOF SURFACE - SEE COMMENT**  
**MATERIAL - Asphalt**

At twenty years old the roof surface is near the end of its useful life, but is serviceable at the present time. Moss should be removed from the roof surface as this will shorten the life expectancy of the shingles.

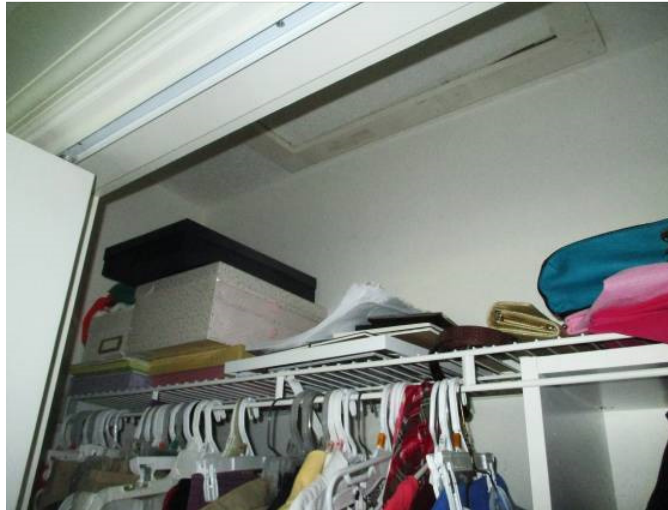
**17. ACCESS TO ATTIC AREA -  
Limited**

Shelving and storage material prevented access through the hatch and into the attic. Attic framing was viewed from this opening. Evaluation based on visible structure.

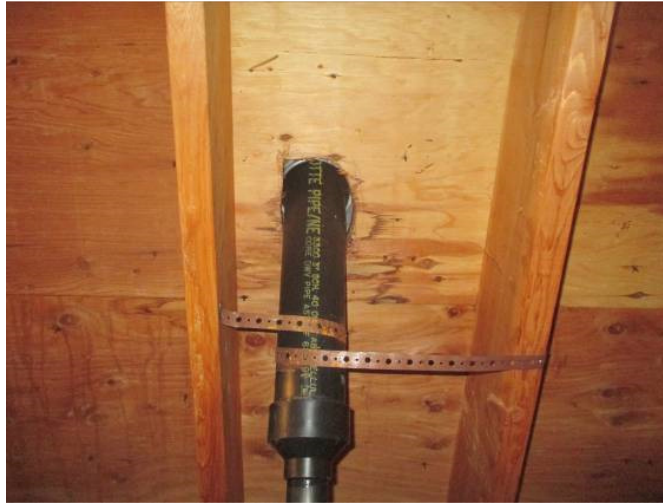
### 24. FLASHING -

There is evidence of past water leakage around vent pipe flashing.

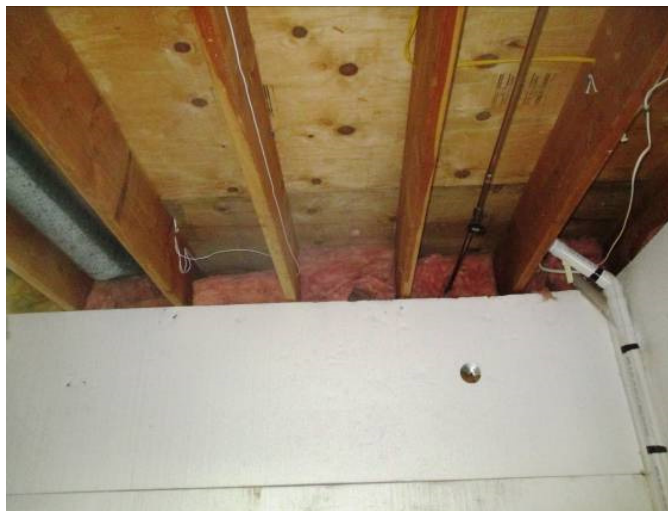
33. VISIBLE HEADERS - SEE COMMENT

Headers and sills are completely covered with insulation in the small unfinished basement area.

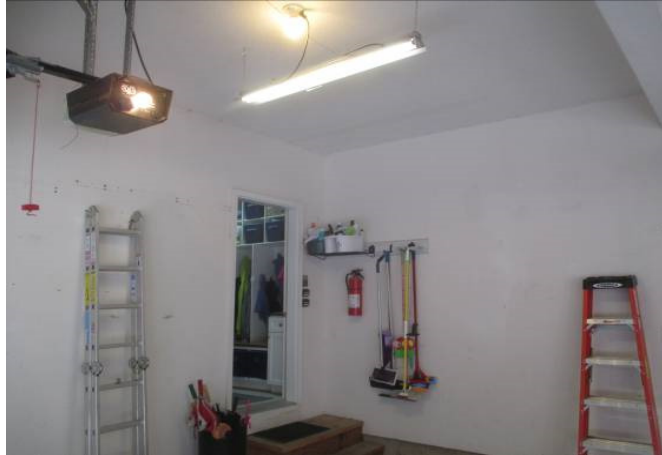
### 34. VISIBLE SUB FLOOR -

Due to finished construction, garage framing members are not visible for inspection.

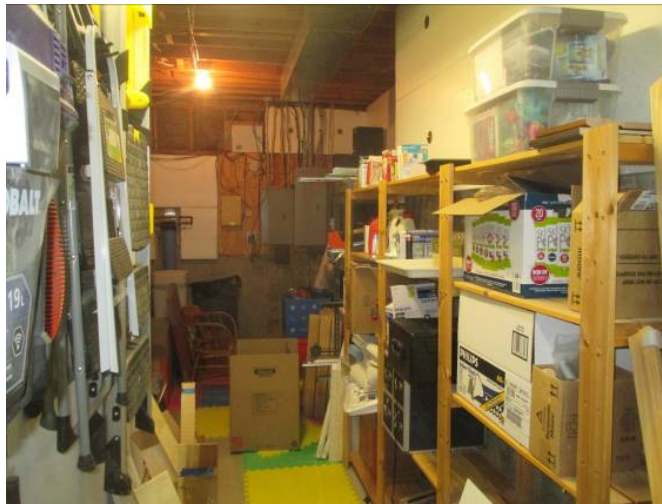
### 36. WERE ANY AREAS OF THE PROPERTY OBSTRUCTED OR INACCESSIBLE? YES

Storage material prevented access to some portions of the basement and garage.

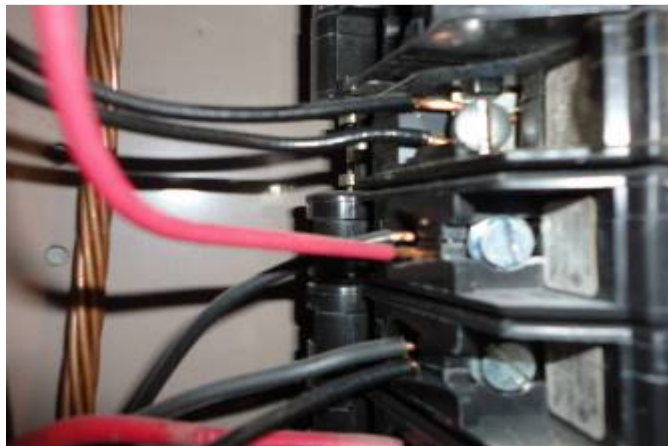
**39. DISTRIBUTION CENTER - SATISFACTORY**

There are two wires attached to some circuit breaker. Each circuit should be protected by a separate breaker.

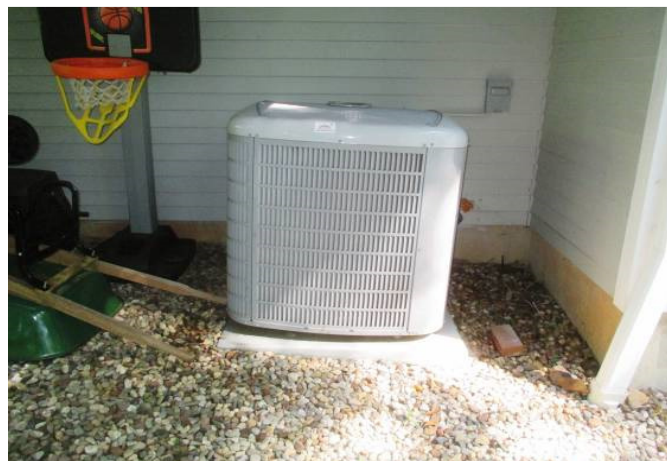
### 49. CENTRAL AIR CONDITIONING SYSTEM -

Air conditioning unit should be operated as close to level as possible to reduce wear.

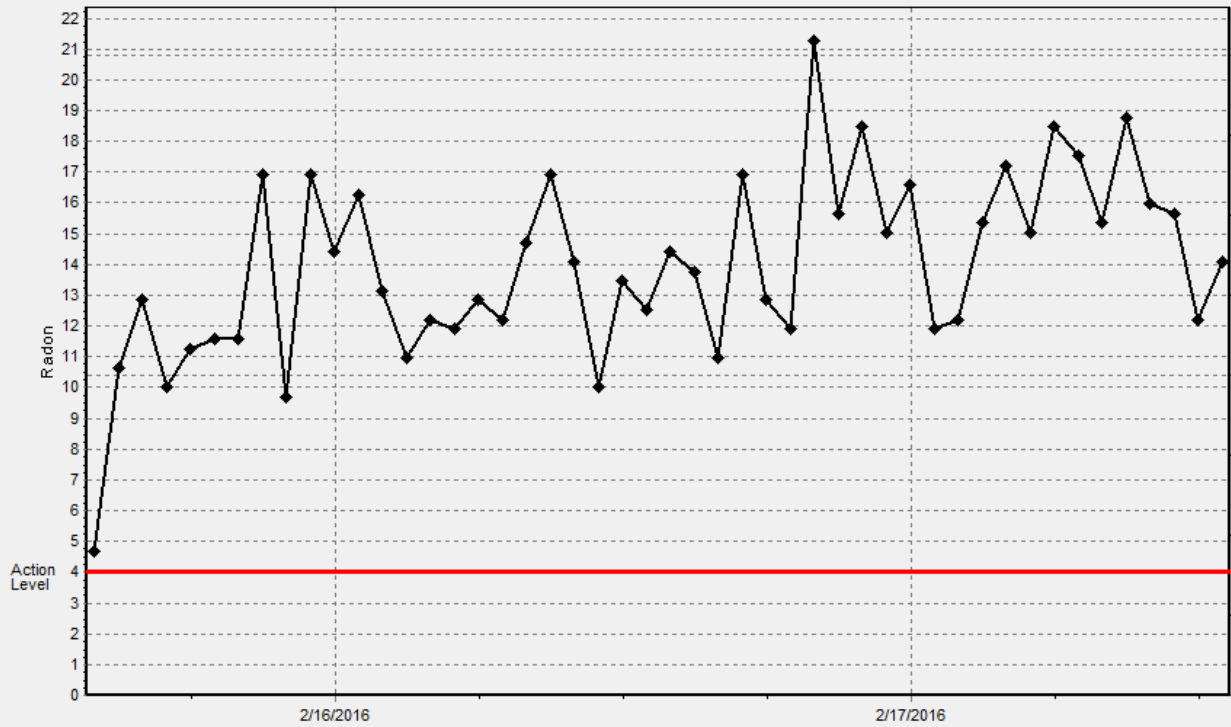
Continuous Radon Monitor Model 1028 S/N: 106028005

**Overall Average: 13.9**  
**EPA Average: 14.3**

Overall Avg: 13.9 No Motion Detected
